# Manhole Inspection Summary

Manhole # S33UU1011MH

Insp Date: **3/19/07 11:24 AM**

**Location** Address: **134 HOMELAND AVE**

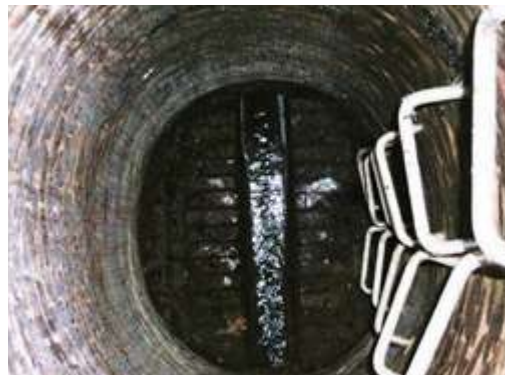
Top View

Evidence of surcharge - Bench debris.  
Channel debris.

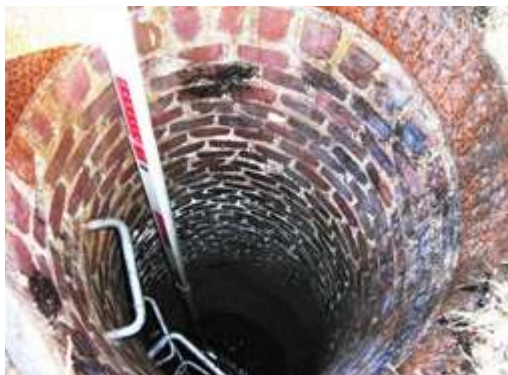
Defect

Frame leaks. Adjustment, Corbel and  
Barrel infiltration.

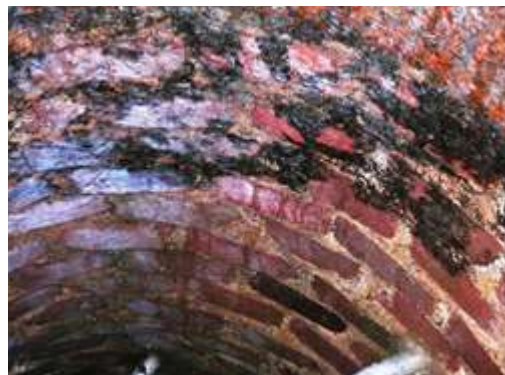
Defect

Frame leaks. Adjustment and Corbel  
infiltration.

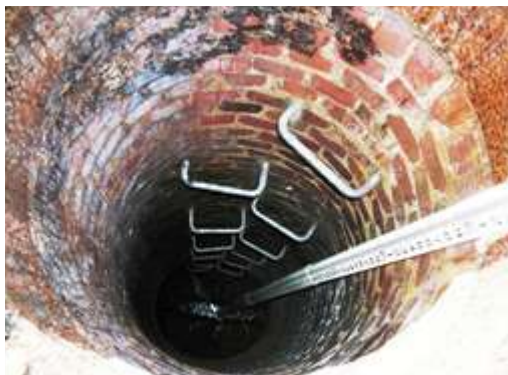
Defect

Adjustment, Corbel and Barrel infiltration -  
other side.

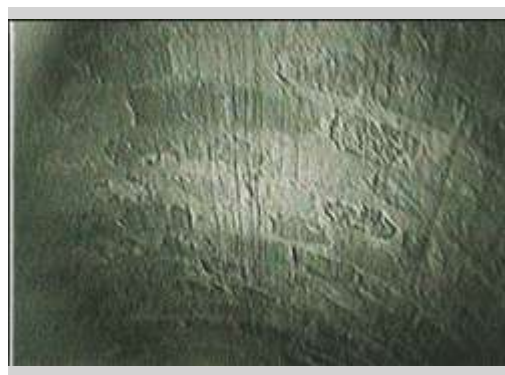
Defect

Barrel infiltration.

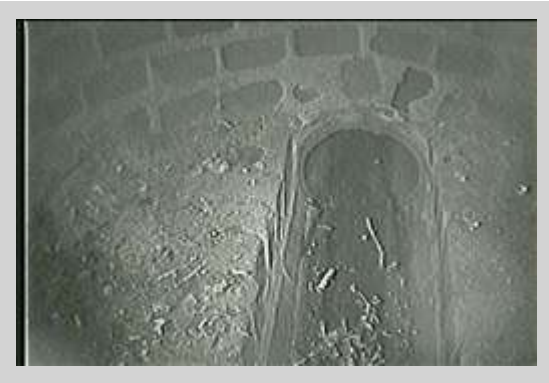
### 8 in. Circular Gravity Sewer Pipe Out @ 12 O'Clock

Infiltration: **Evidence** Pipe Seal Cond: **Unknown**

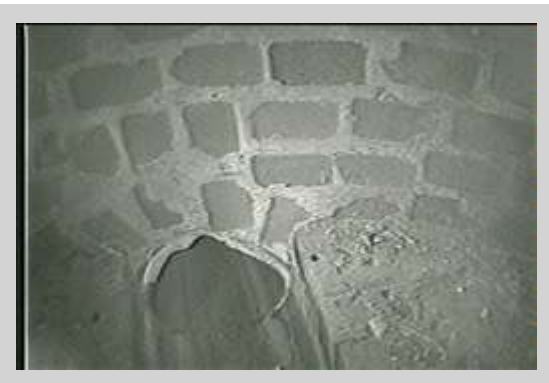
### 8 in. Circular Gravity Sewer Pipe In @ 6 O'Clock

Infiltration: **None** Pipe Seal Cond: **Broken**
